**DAMAGE ASSESSMENT AND RESTORATION PLAN**

**for the  
2014 Bay St. Elaine Oil Spill  
(NRDA CASE FILE #LA2014\_1025\_1120)**

**2016 Lake Grand Ecaille Oil Spill  
(NRDA CASE FILE #LA2016\_0725\_0630)**

**2016 Bay Long Oil Spill  
(NRDA CASE FILE #LA2016\_0905\_1017)**

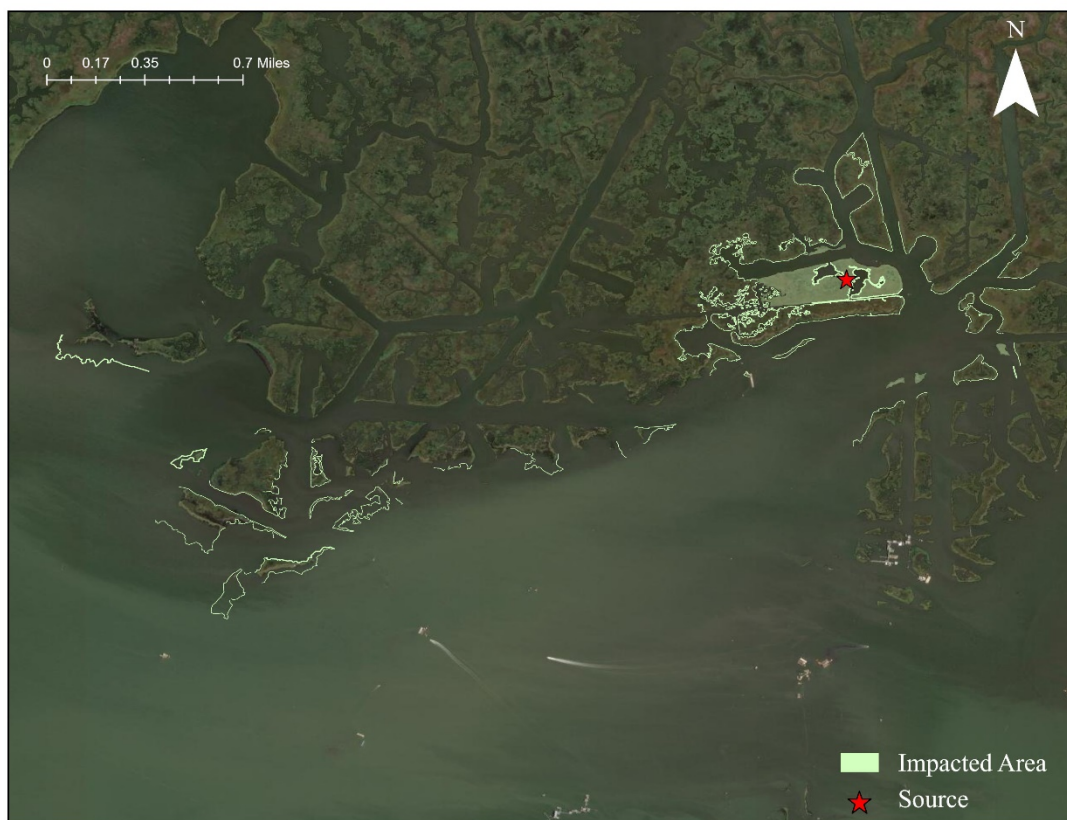
**Figure 3.2 Area impacted by the Lake Grand Ecaille Incident**

The Trustees noticed shortly after the spill occurred that oiled marsh shoreline was beginning to slough-off, or erode, at locations near the source. The oil resulted in immediate impacts to marsh vegetation through direct contact and coating of plant surfaces. As a result, the Trustees and Hilcorp conducted three NRDA preassessment site visits on 07/28/2016, 10/05/2016, and 06/08/2017. The objective of the NRDA preassessment site visits was to document the oiling along the marsh shoreline. During the three NRDA preassessment site visits that were conducted to assess the ongoing marsh impacts, the Trustees and Hilcorp traveled through the waterways and marshes by boat to observe and photograph the area. Observations showed sheen emanating from disturbed sediments as well as varying degrees of oiling on marsh vegetation. The Trustees determined that approximately 60.53 acres of marsh was exposed and injured due to the result of the incident (Figure 3.2, see Appendix C).

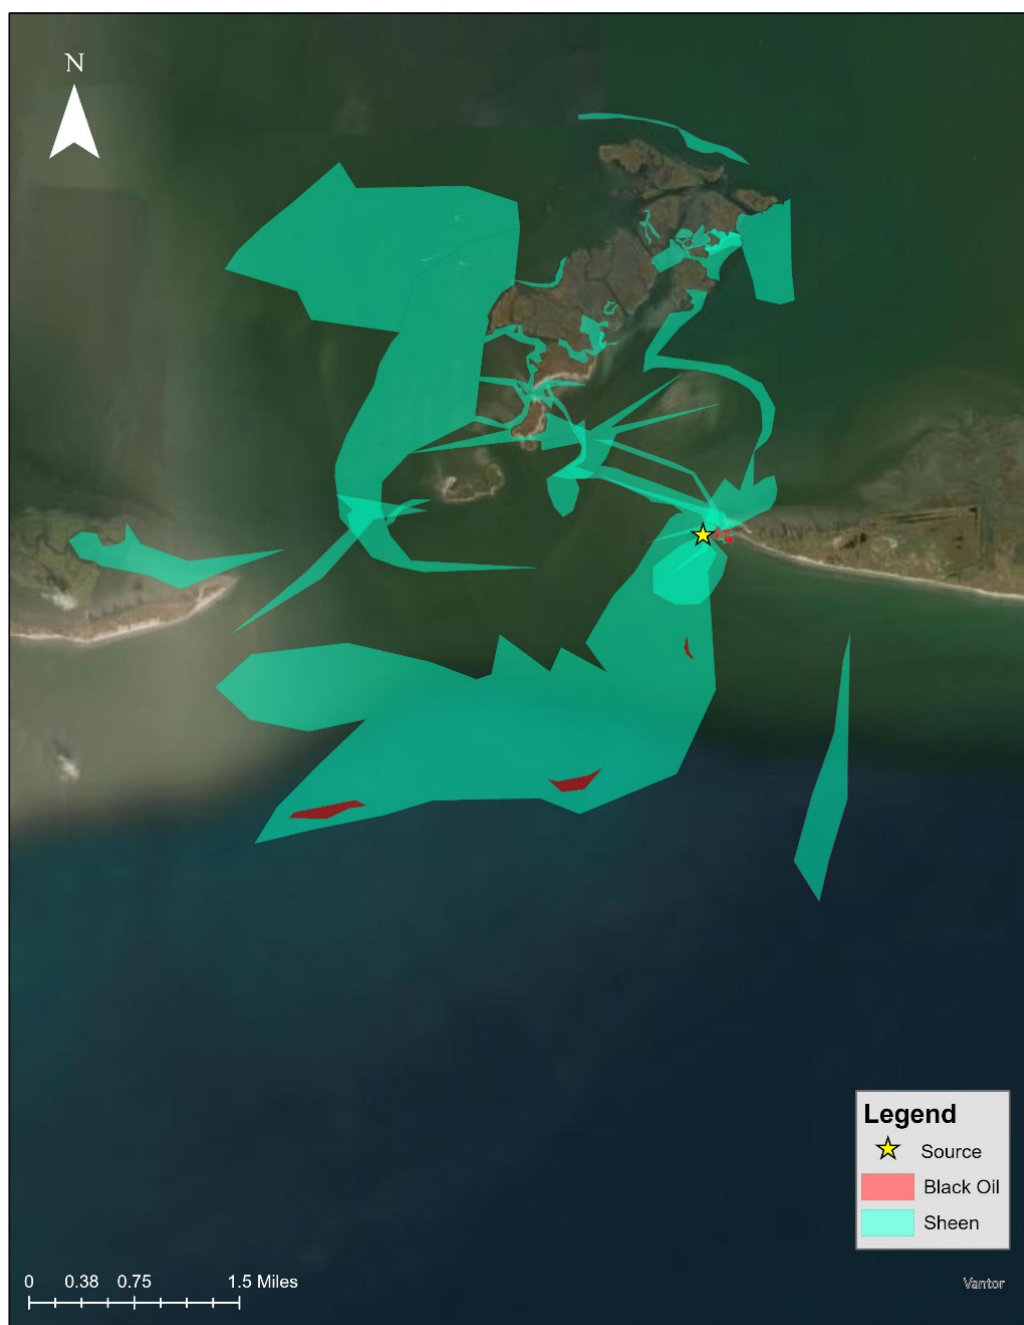
**Figure 3.3 Area impacted by the Bay Long Incident**

The area impacted as a result of the spill is characterized by high avian use, as evidenced by the restoration project that was under construction at the time of the spill. The Trustees determined that the oiling map depicted in Figure 3.3 documented observations during the Response and Preassessment phases. Oiling observations were made over a period of eight days and were overlaid into one map to depict not only the extent of oiling but, to the degree possible, the areas of re-oiling. The area is frequently utilized for avian foraging, roosting, and/or nesting, and, as a result, there was a credible risk of bird exposure or injury due to the spill. Shortly after the incident occurred, Wildlife Response Services established a wildlife rehabilitation center at the LDWF Marine Lab on Grand Isle, LA. Trained wildlife professionals representing both the Trustees and Hilcorp implemented foot and boat based searches between 09/05/2016 - 09/16/2016 (11 days) to document as well as capture/rehabilitate (if possible) oiled birds and wildlife. These data were also retained and evaluated for NRDA preassessment purposes. Table 3.2 details the over 26,800 observations made of birds dead or with varying degrees of oiling (e.g., no visible oil, unknown, oiled) during the course of the bird surveys.

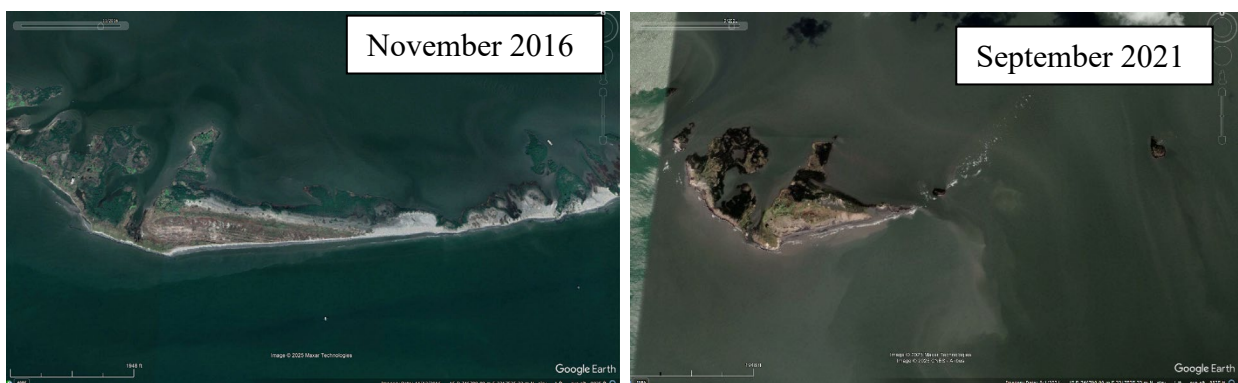
**Figure 3.8 Google Earth image of Timbalier Island in November 2016 (after impacts from the incident and prior to Hurricane Ida) and in September 2021 (immediately after the passage of Hurricane Ida)**

As mentioned previously, Hurricane Ida hit the Louisiana coast on August 26, 2021, changing the footprint of the island and washing away some of the mangrove habitat that was impacted (Figures 3.8). The Trustees took this into consideration and truncated the mangrove injuries to reflect the reduction in mangrove habitat after the storm (Figure 3.9). The *Spartina*, algal flat, and sand beach flat injury periods were over prior to hurricane Ida's arrival, so no adjustments needed to be made to those categories. Table 3.15 provides acreages as well as service loss and recovery time information prior to and after Ida's effects on Timbalier Island.

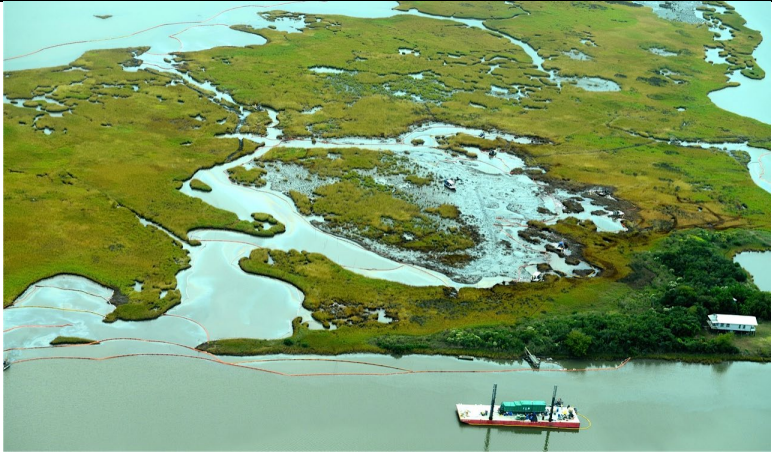
| | <p>Boom placement and oil in cove</p> |

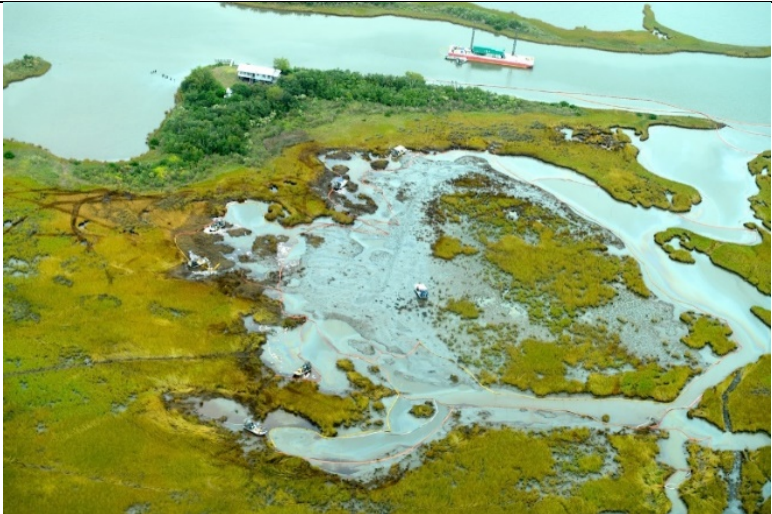
| | <p>Aerial view of the spill area depicting oiling and airboat trails through the marsh</p> |

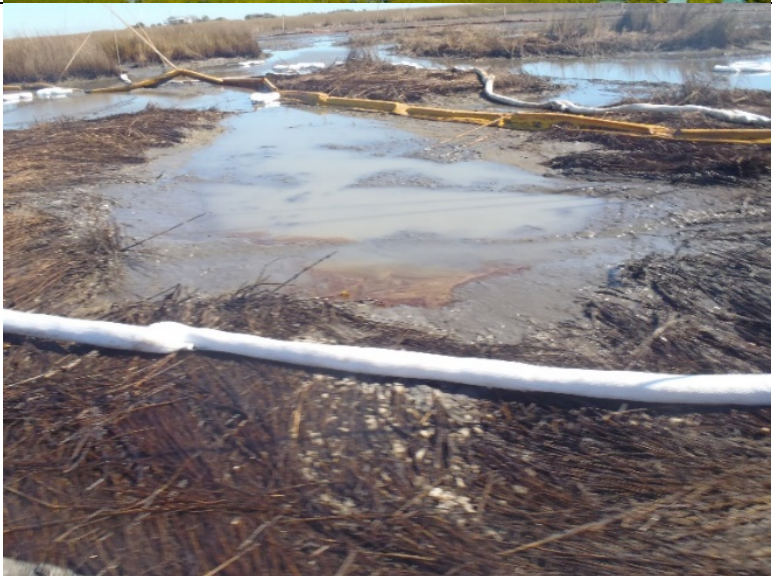
| | <p>Hard and soft boom in area with oiled, laid over vegetation</p> |

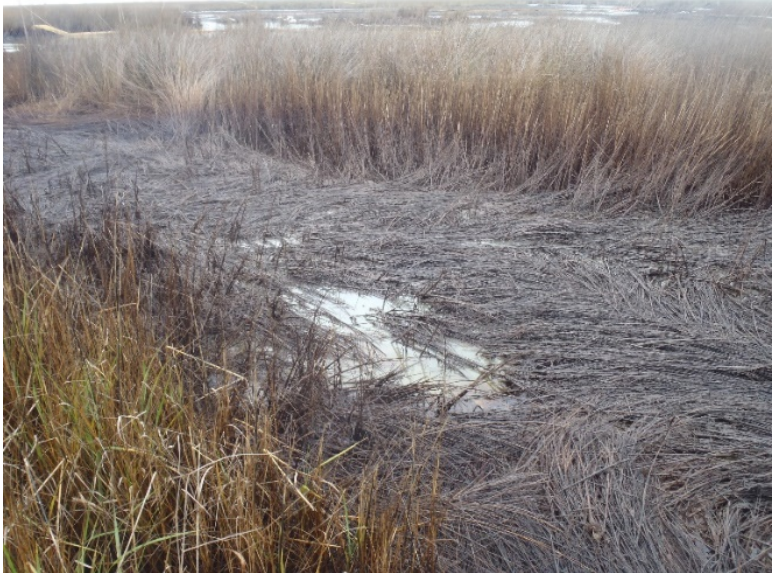
| | <p>Oiled, laid over vegetation at the source of the incident</p> |

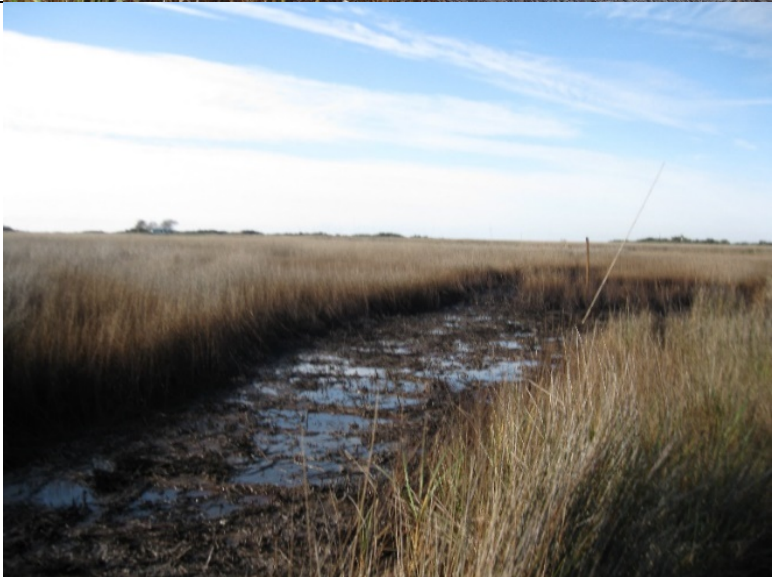
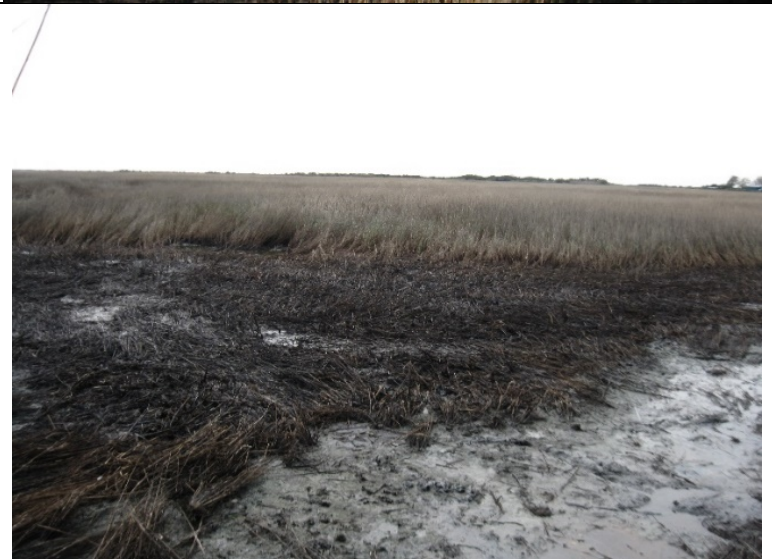
| | <p>Area around the source after cutting of vegetation</p> |
| | <p>Area around the source after cutting of vegetation</p> |

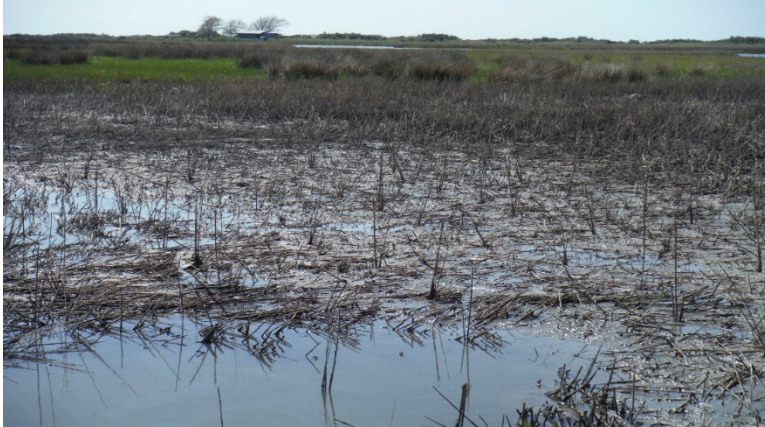
Failed planting initiated by Landowner in impacted area of marsh

In the fall of 2015, the landowner conducted a planting of *Spartina alterniflora* in the areas experiencing marsh dieback. The Trustees were not notified prior to commencement of the activity so were not a part of the planning and implementation of the planting. On 02/29/2016, the Trustees conducted a site visit to investigate planting and observed a failure of most of the plantings to survive.

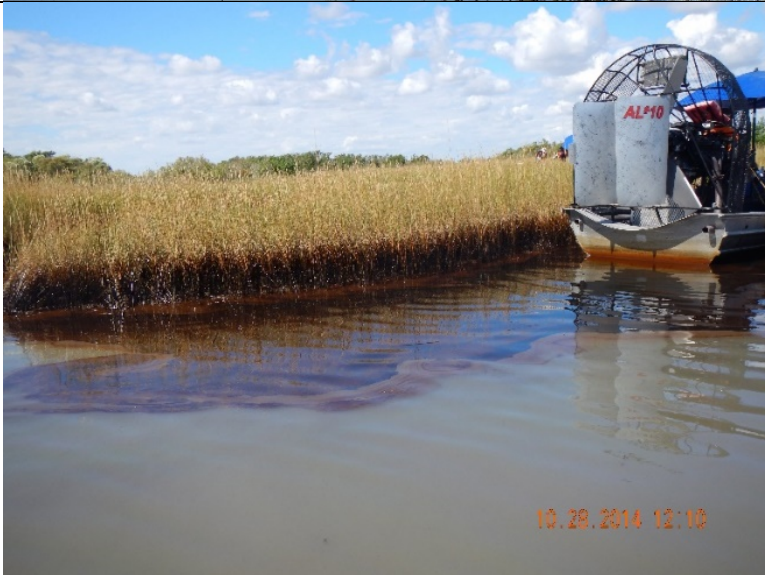
Response activity in oiled area; airboat traveling through oil and “bathtub ring” of oil on vegetation

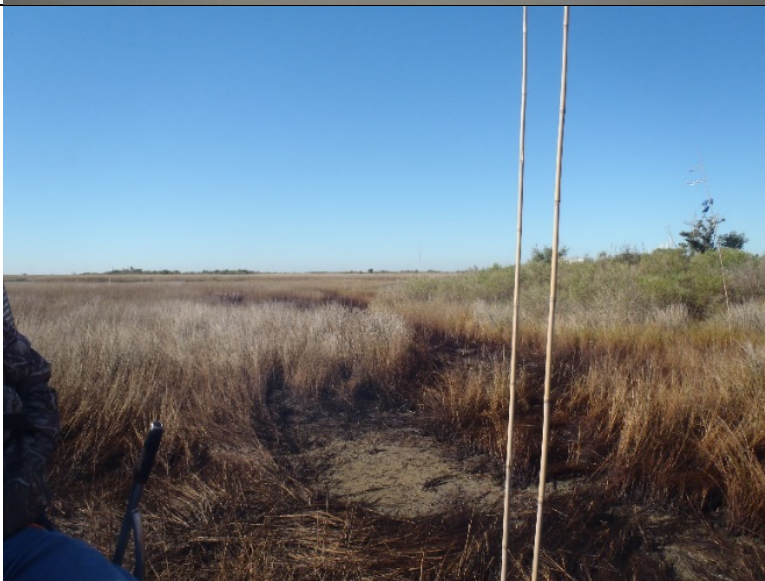
Oiled airboat trails through marsh as a result of Response activities

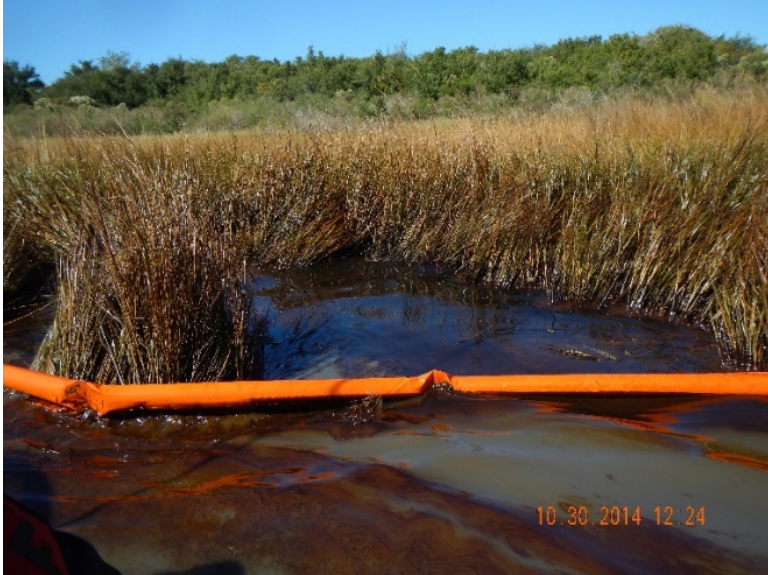
Hard boom near oiled  
vegetation

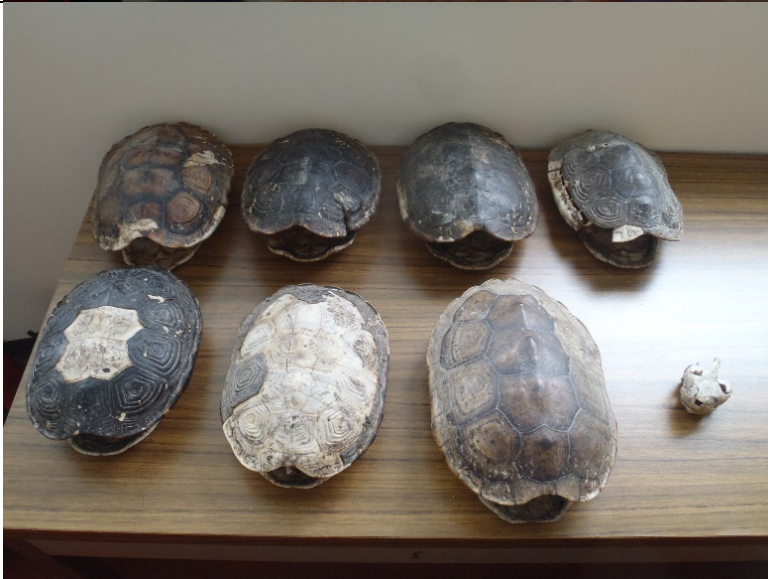
Diamondback terrapin carcasses  
incidentally discovered during  
site visit 09/22/2015

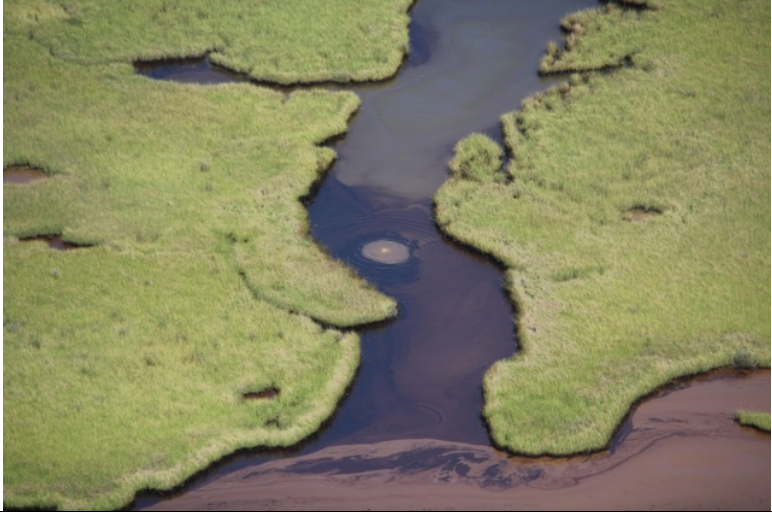
| | Incident source |

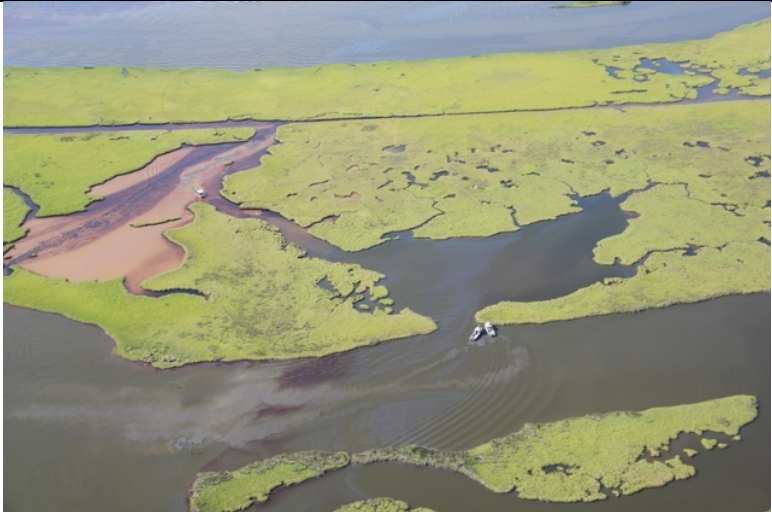
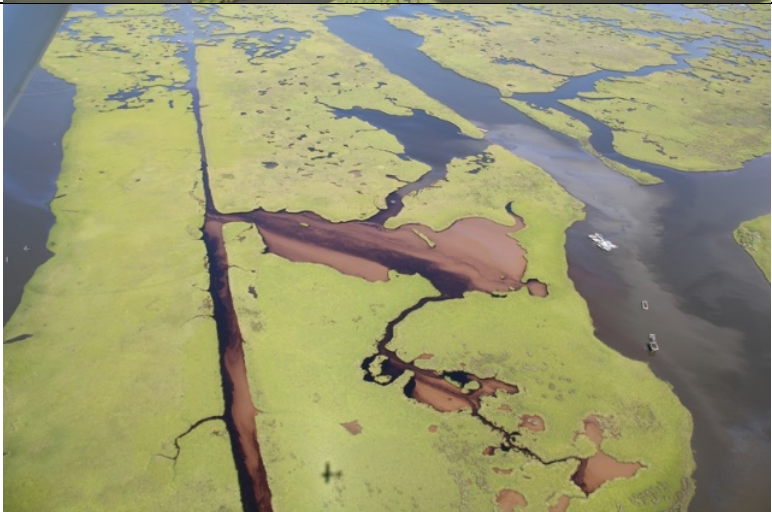
| | Oiled <i>Spartina</i> marsh and waterway |
| | Oiled <i>Spartina</i> marsh and waterway |

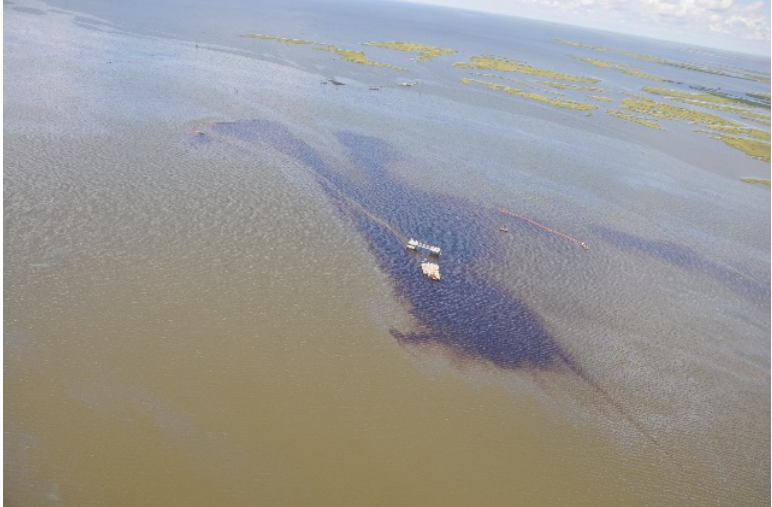
| | <p>Oil in waterway</p> |

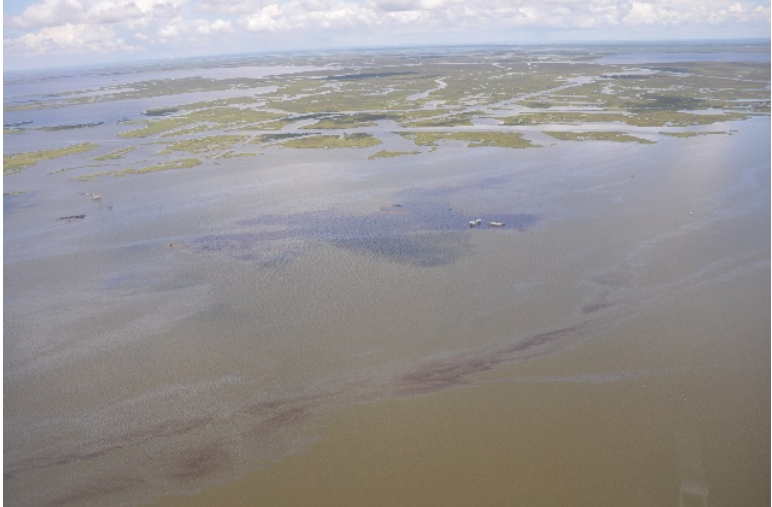
| | <p>Oil streamers in Lake Grand Ecaille</p> |

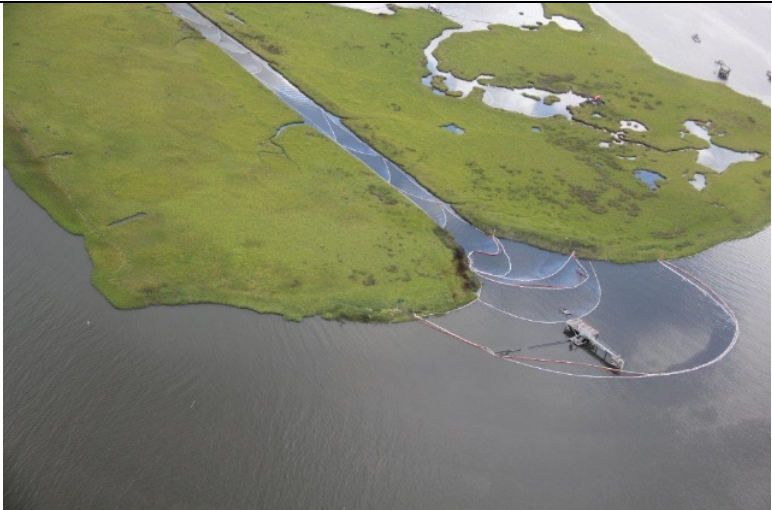
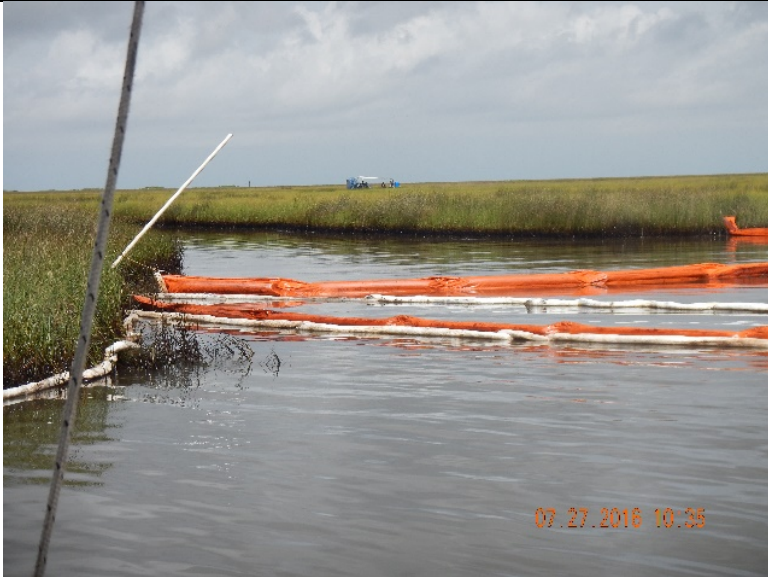
| | <p>Hard and soft boom placed to contain oil in the channel</p> |

Hard and soft boom placed to contain oil in the channel

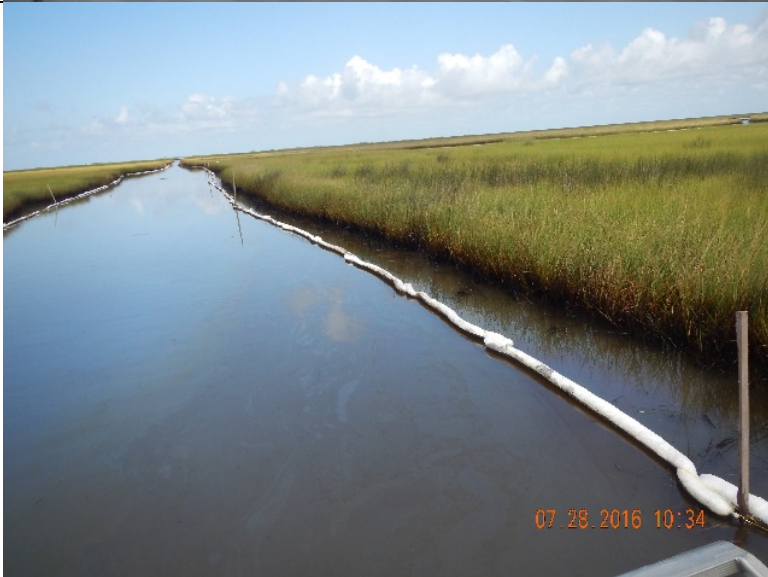
Soft boom lining a waterway

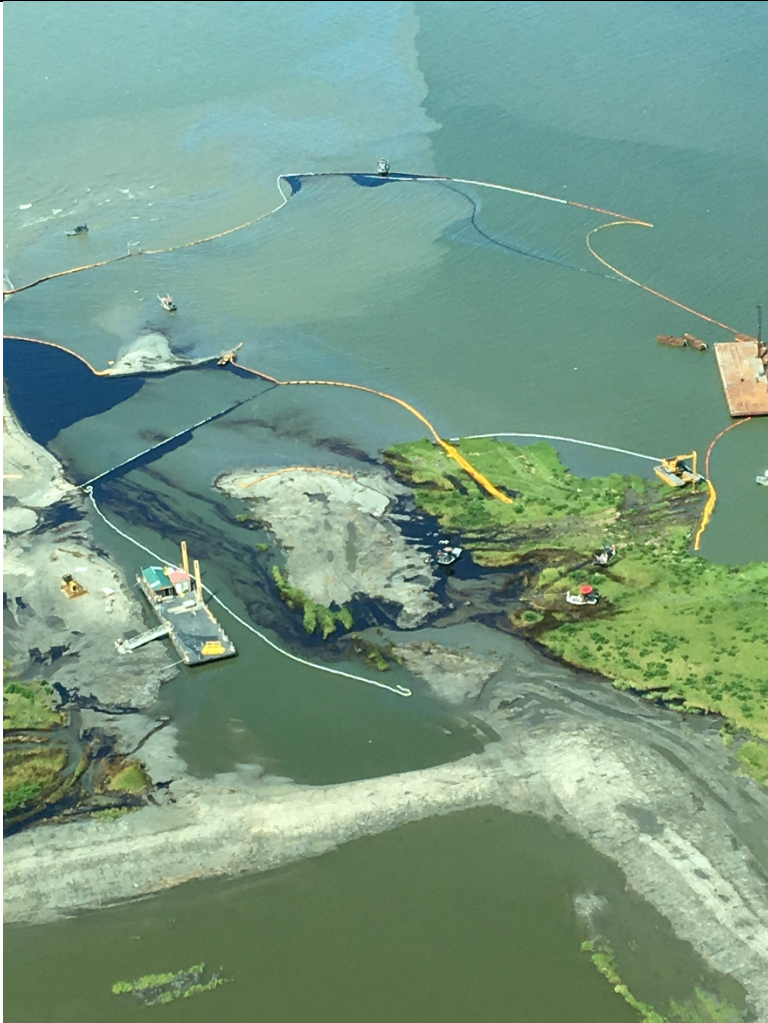
Aerial view of the spill source, boom, pooled oil, and sheen on the water outside of the boom

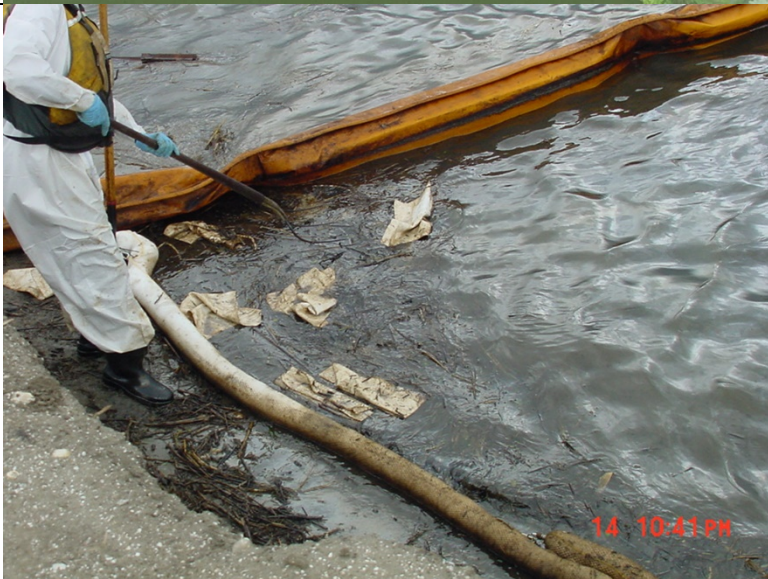
Hard and soft boom with sorbent pads at beach edge

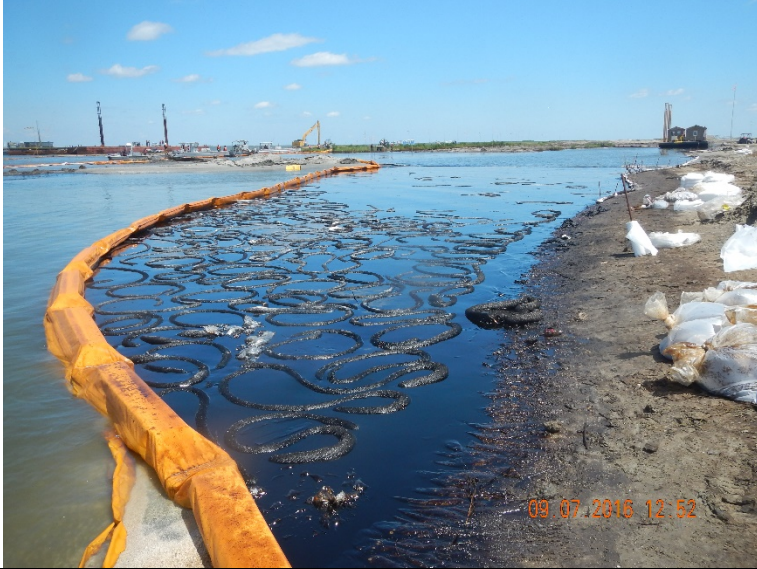
Oil-soaked soft boom inside hard boom perimeter at marsh edge

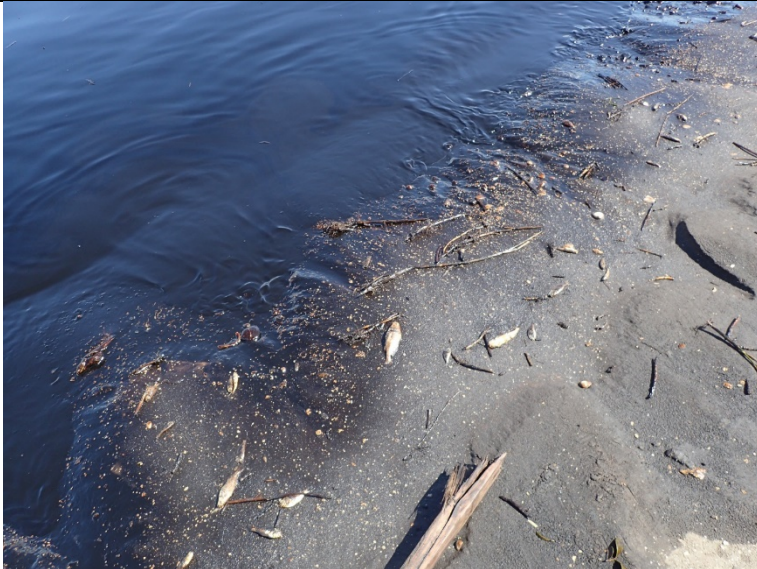
Oil and dead fish washing up on Chenier Ronquille

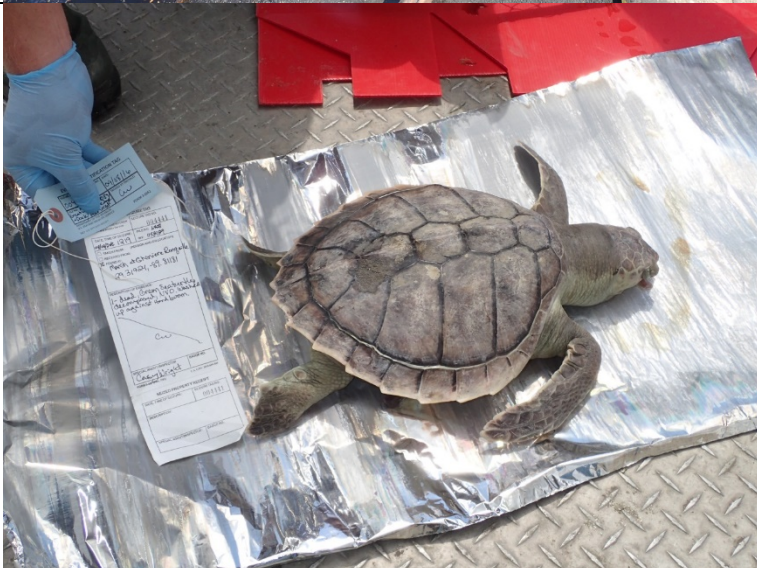
Dead Kemp's Ridley sea turtle

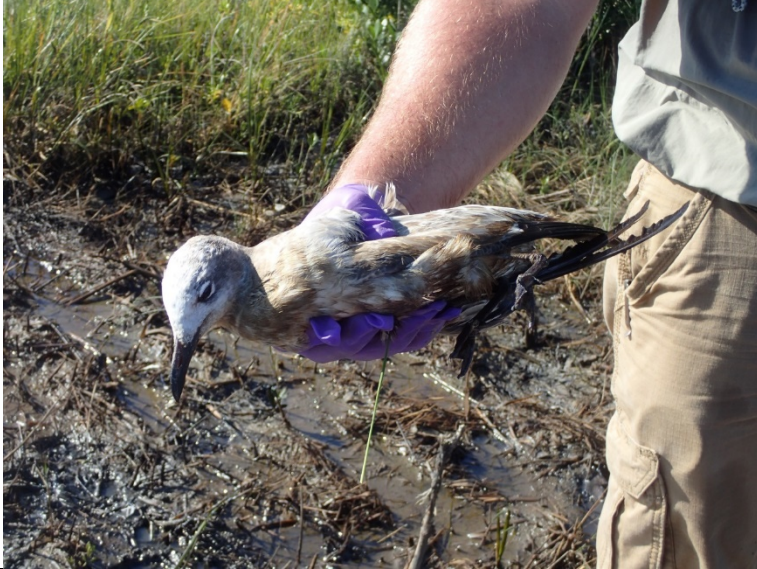
Lightly oiled laughing gull

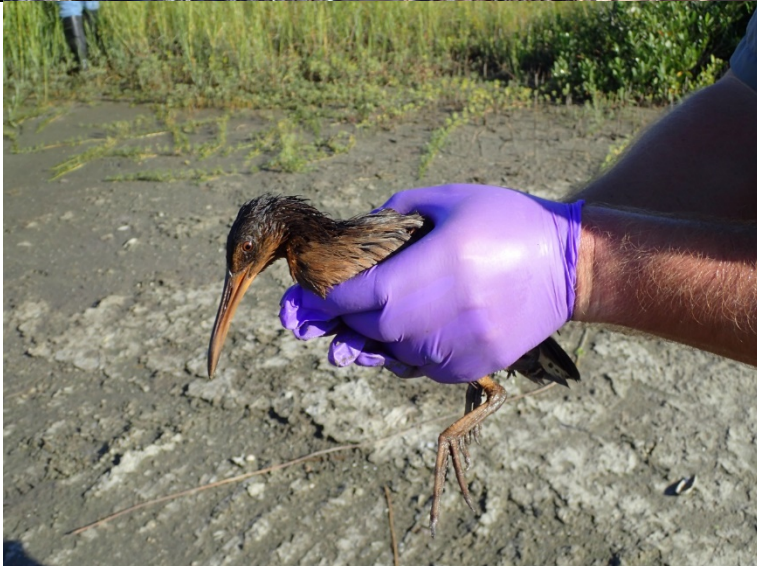
Heavily oiled clapper rail

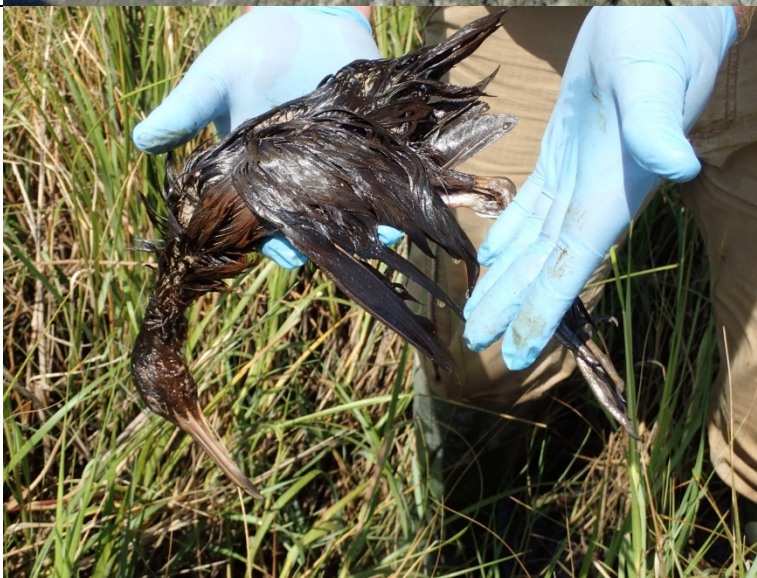
Oiled, dead clapper rail

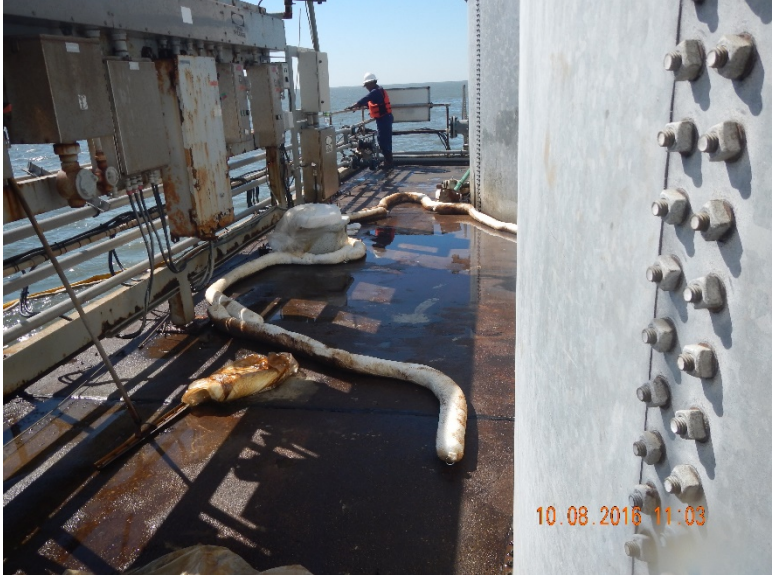
| A photograph showing an oil spill on a metal platform deck. A large, dark, irregular pool of oil is visible, with a white hose lying across it. In the background, a worker in a red shirt and white hard hat is visible. The date and time stamp '10.08.2016 11:03' is visible in the bottom right corner of the image. | <p>Oil on Caillou Island Tank<br/>Battery 25 platform</p> |

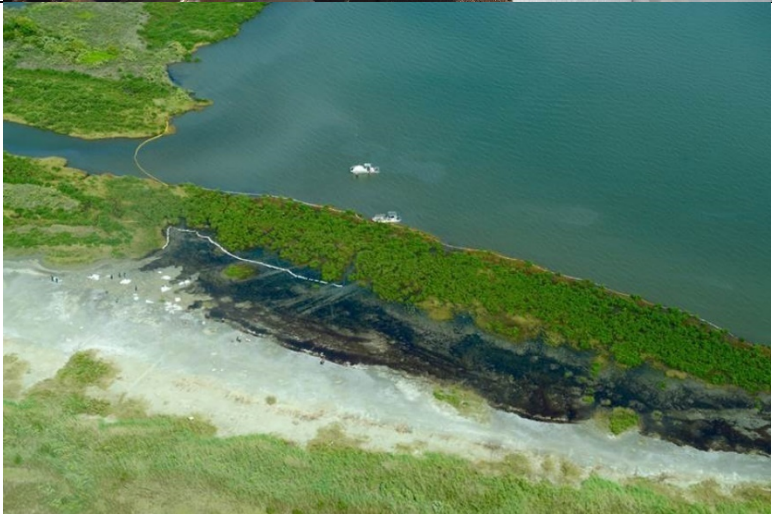
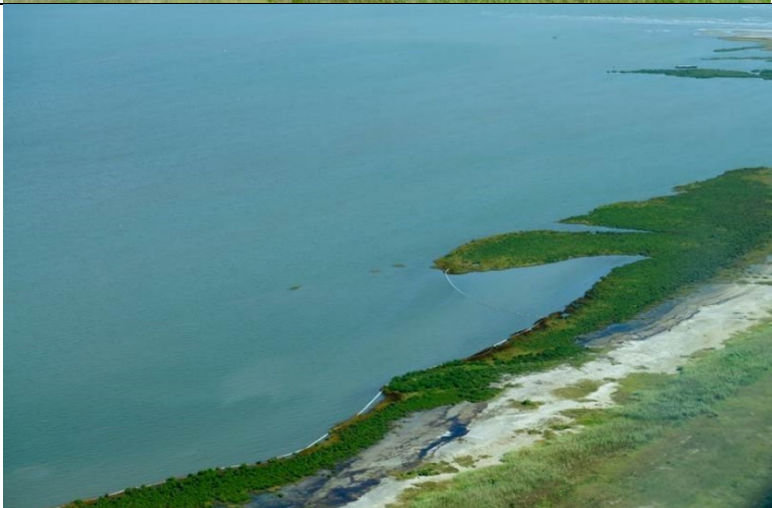
| An aerial photograph showing a coastal area with green mangroves and sand flats. A large, dark, irregular area of oil spill is visible, covering a significant portion of the mangroves and sand flats. The water is a light blue-green color. | <p>Impacted mangroves and<br/>algal/sand flats on Timbalier<br/>Island</p> |
| An aerial photograph showing a coastal area with green mangroves and sand flats. A large, dark, irregular area of oil spill is visible, covering a significant portion of the mangroves and sand flats. The water is a light blue-green color. | <p>Impacted mangroves and<br/>algal/sand flats on Timbalier<br/>Island</p> |

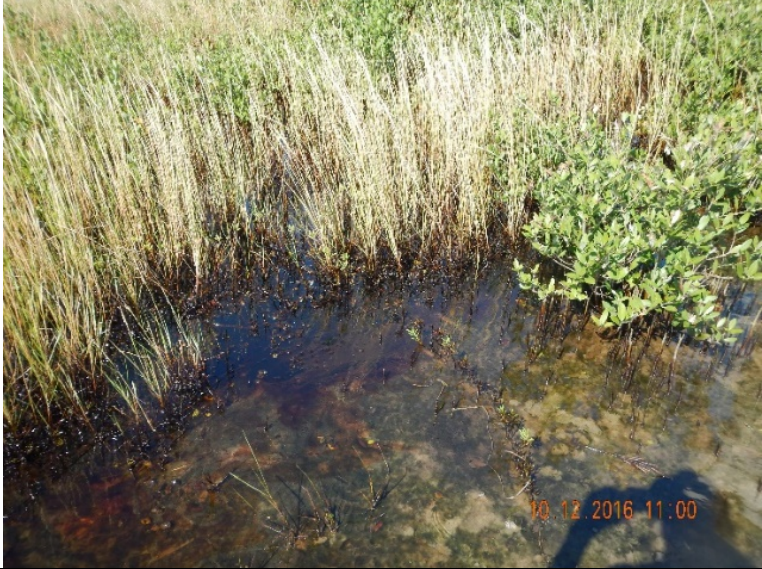
| <p>A close-up photograph showing a dense patch of tall, yellowish-brown <i>Spartina</i> grasses and green mangrove plants. The water is dark and murky, with many small, light-colored propagules floating on the surface. A timestamp in the bottom right corner reads "10.12.2016 11:00".</p> | <p>Oiled <i>Spartina</i> and mangroves<br/>with propagules floating in oil</p> |

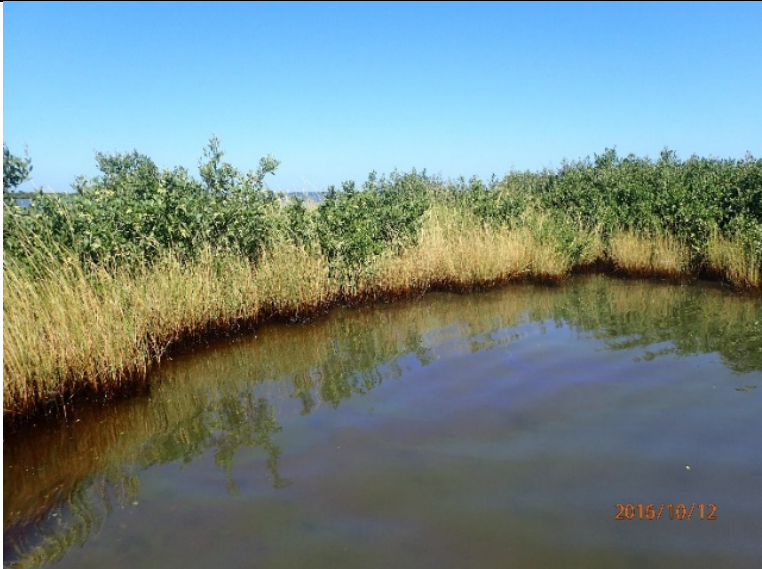
| <p>A photograph of a mangrove wetland area. In the foreground, there is a calm body of water reflecting the sky. The background is filled with a dense line of green mangrove trees and tall, yellowish-brown <i>Spartina</i> grasses. A timestamp in the bottom right corner reads "2015/10/12".</p> | <p>Oiled <i>Spartina</i> and mangroves</p> |

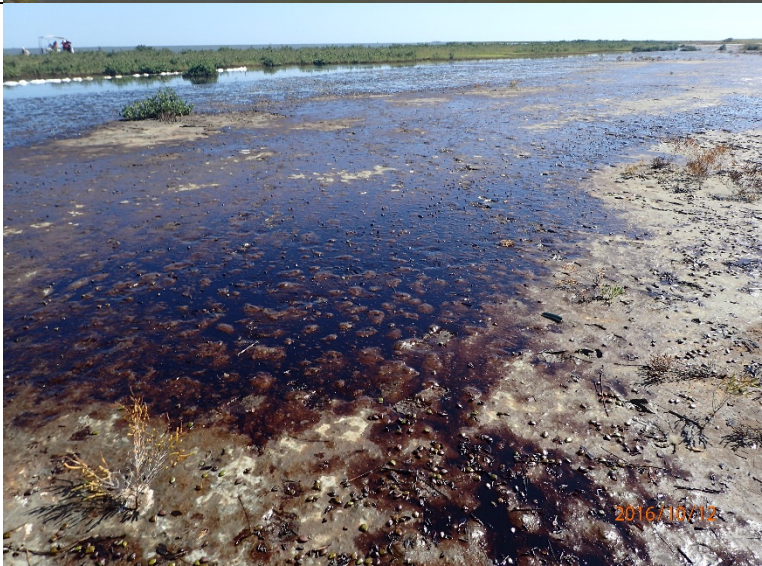
| <p>A photograph of a wide, flat mangrove area. The foreground is covered in a thick layer of dark, brownish-black oil and debris, with some small, yellowish-brown plants growing through it. In the background, there is a line of green mangrove trees under a clear blue sky. A timestamp in the bottom right corner reads "2016/10/12".</p> | <p>Mangrove propagules in oil on<br/>algal/sand beach flat</p> |

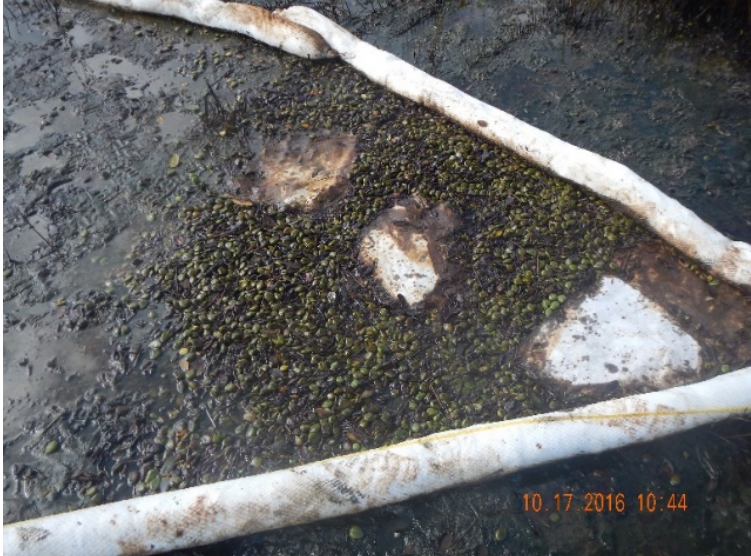
| | <p>Oiled propagules, boom, and sorbent pads</p> |

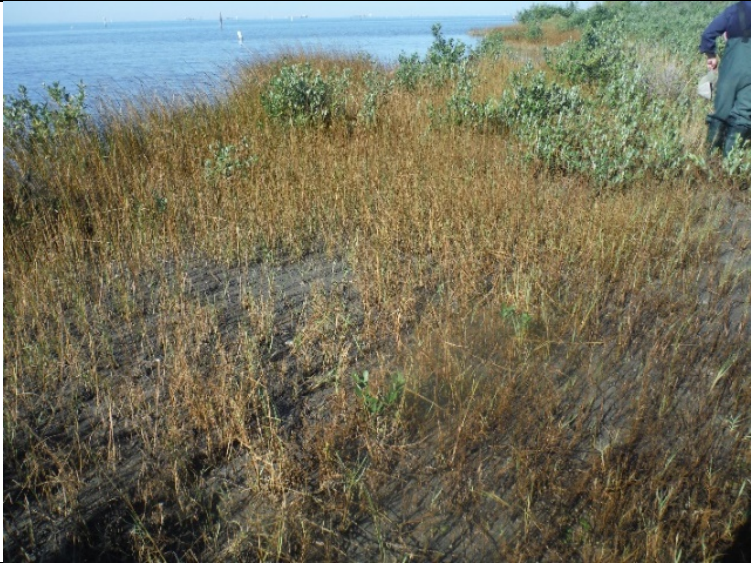
| | <p>Area of affected <i>Spartina</i> and mangroves</p> |

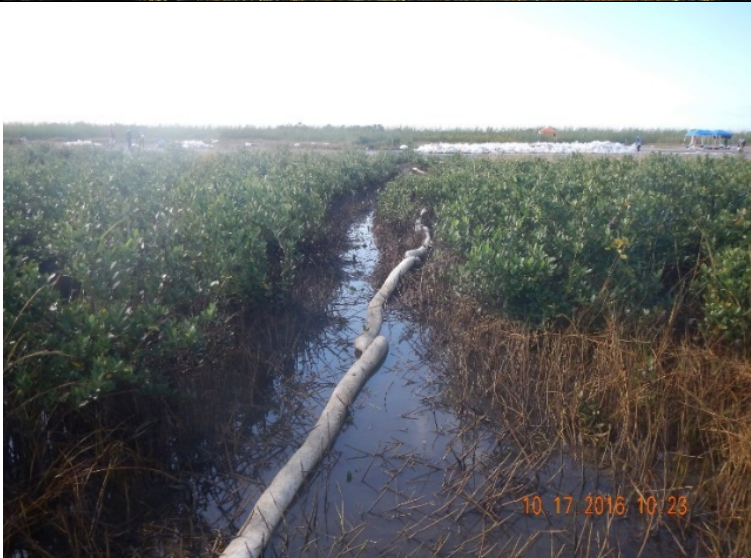
| | <p>Example of Response injury to mangroves and <i>Spartina</i> from foot and UTV traffic</p> |

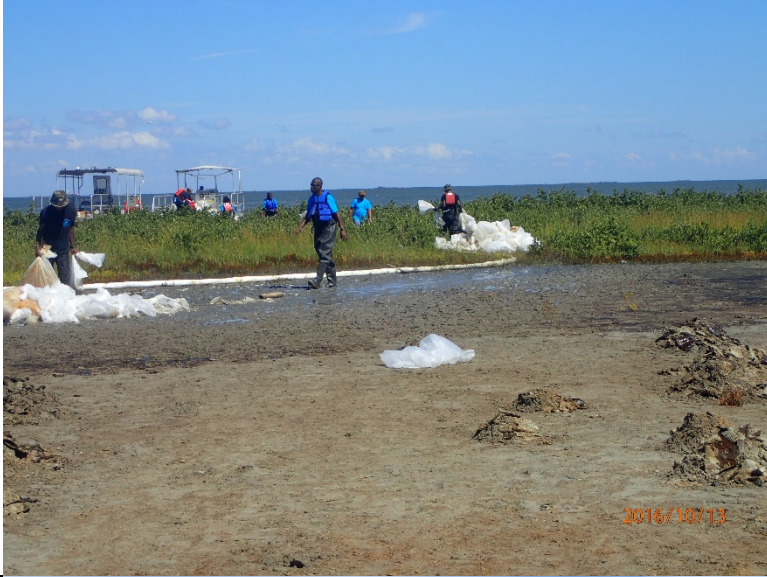
Response activity: scraping algal and sand beach flats and bagging up oily debris

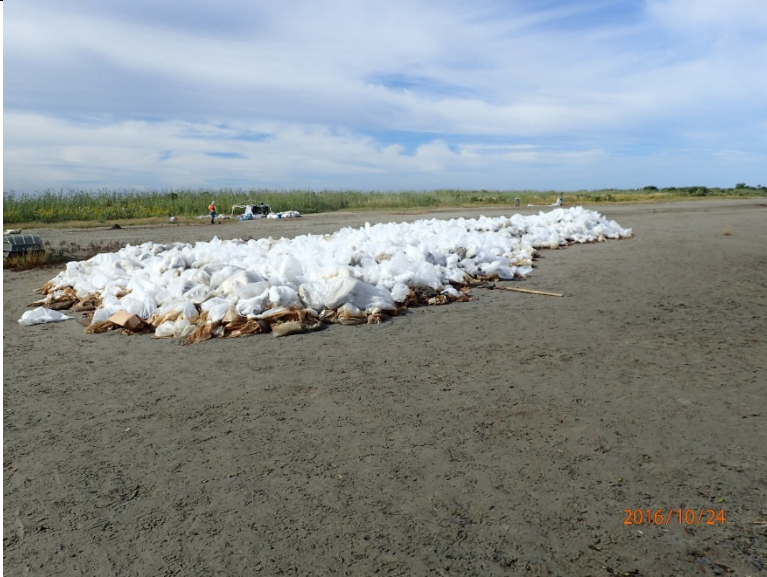
Bags of oily sand/propagules scraped up from algal/sand flat area
